MANAGING THREATENED SPECIES AND WEEDS ON STATE ROADS IN TASMANIA

This user guide explains the Enviromark system and outlines its application to the management of priority threatened plant populations and serrated tussock sites on DIER roadsides.

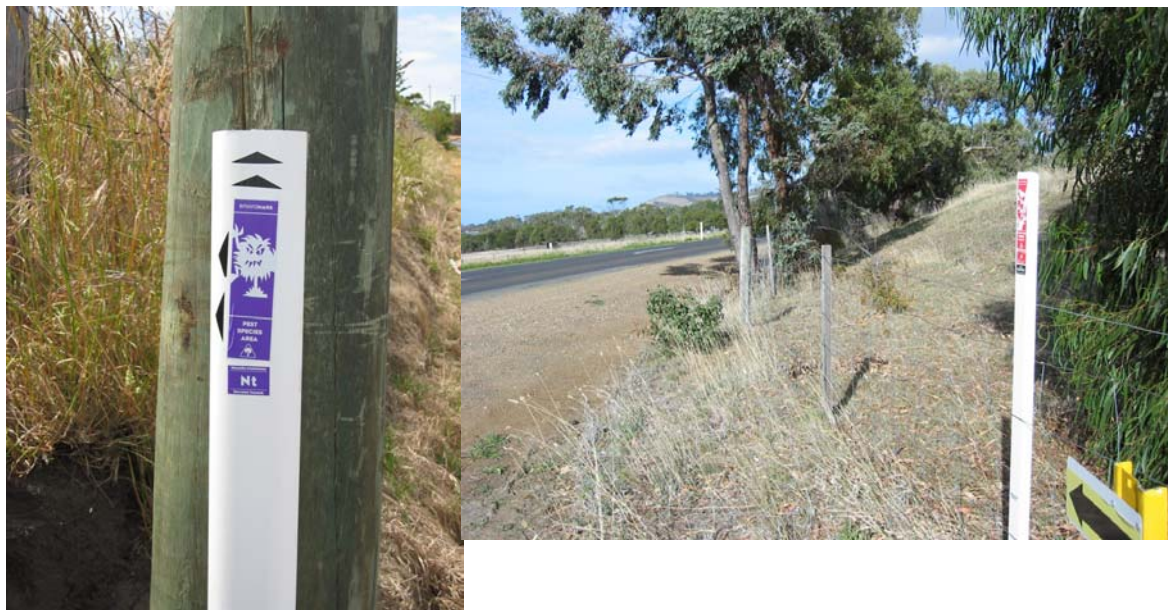
Field Markers have been put in place in both Northern and Southern DIER Regions at 46 locations (as at March 2005). Maps of their locations can be found on the DIER intranet and web site. The field markers show whether it is threatened species or weeds that are being managed at that site. They also indicate the direction of the management area with arrows and have a contact phone number for more information. Standard white Dura-post posts have been used, placed usually against the road reserve back fence.

Above are examples of a serrated tussock site (left) and a threatened species site (right).

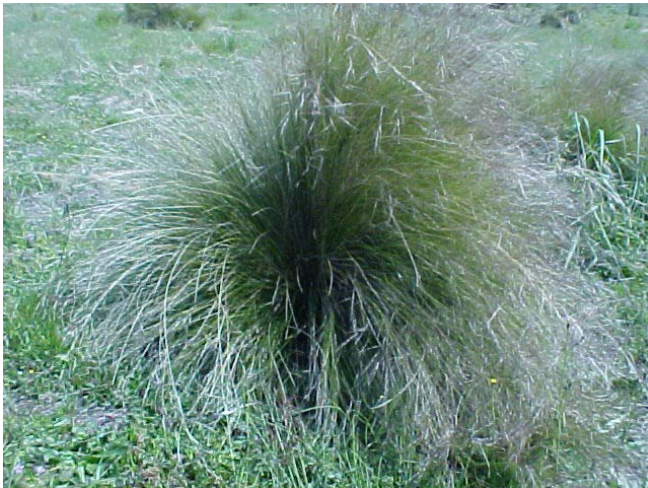
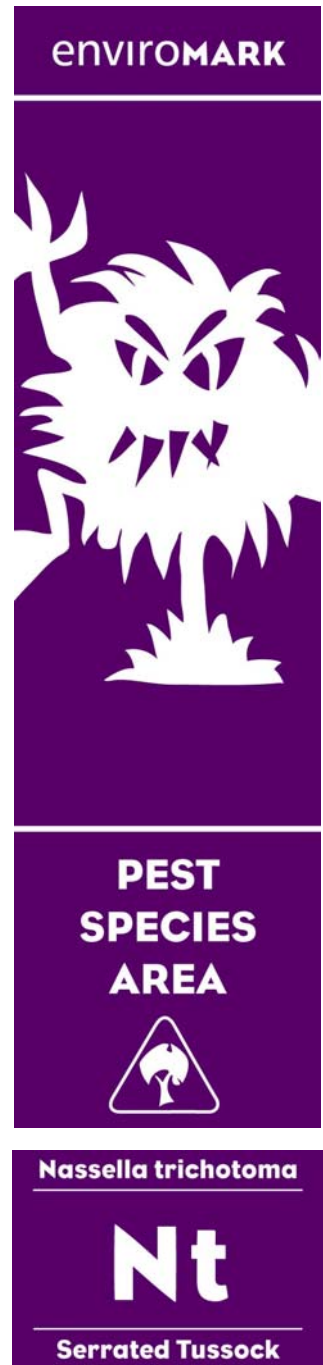
Management areas marked with this symbol, at right, contain pest species, usually significant weeds. In management areas marked with this symbol hygiene is critical.

Below the main marker is this code sticker, shown below at right; Nt, for serrated tussock.

Serrated tussock (left) is causing a greater reduction in pasture carrying capacity than any other weed in Australia. Roadwork hygiene has a major influence on the spread of this Weed of National Significance.

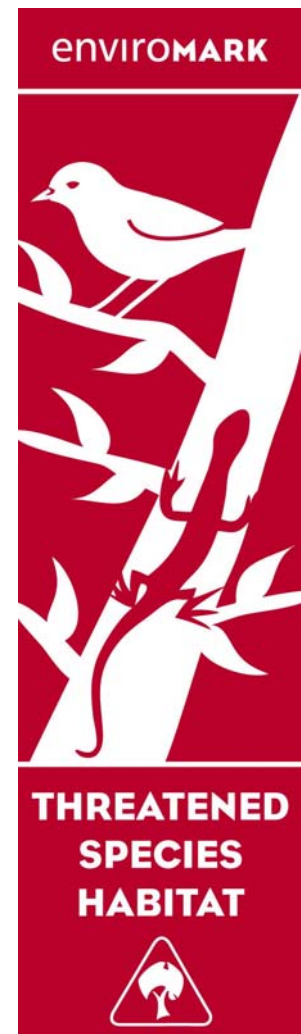
For each of the 43 highest priority DIER threatened species sites there is a unique site number, shown on the field marker and on the accompanying specification. Each site has a different specification.

There are three types of code; NO SLASHING, Distance Restricted SLASHING and Time Restricted SLASHING. Examples of these codes are shown below.

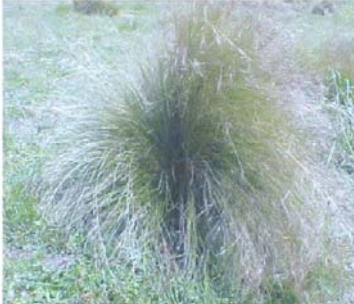
Figure 1: The serrated tussock specification

Nassella trichotoma

Nt

Serrated tussock
